# SONIHULL

Ultrasonic Antifouling System

## PROJECT REPORT

International Project Reference

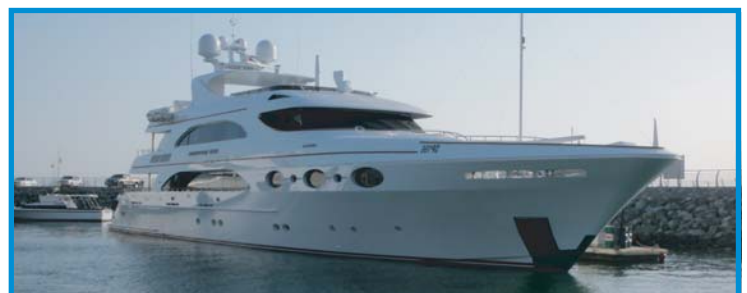
Two raw water inlets (sea strainers) supplying all systems (engines, generators, air conditioning, fire pump and load bank). The two inlets have a conical shaped nylon mesh filter providing very fine filtration of the water entering the cooling system. Due to the fertile nature of the Dubai waters the filters were plagued with rapid algae, vegetation and barnacle growth, to such an extent that the filters required extensive cleaning every week in order to maintain the necessary flow of water. This cleaning process was time consuming, involving a lot of scraping and scrubbing to remove the growth that had managed to weave its roots into the fine filtration mesh.

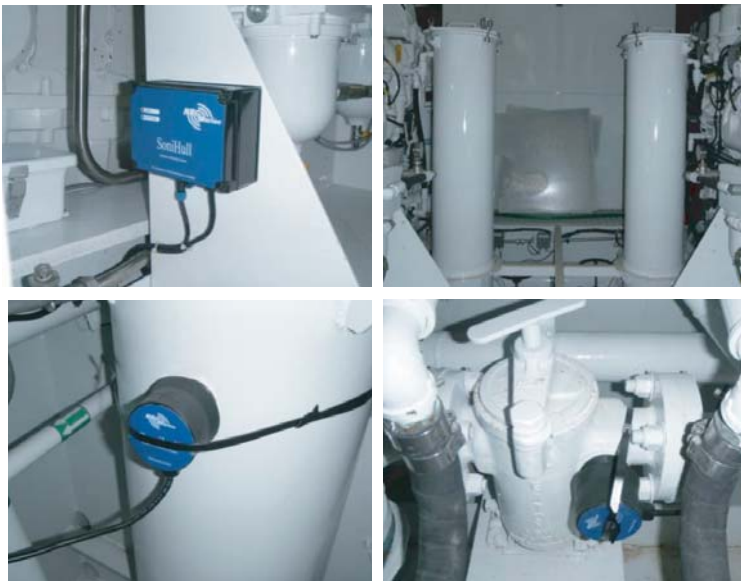
Given the layout of the engine room, the installation involved using 1x Sonihull duo and 1x Sonihull mono system. The IP67 Transducers were mounted on each of the sea chests below the water line and in this case were conveniently located below the floor plates. A third Transducer was mounted onto the side of the isolation valve for the water supply to the water maker, this was to provide protection not only to the valve from the build up of growth that could stop the valve from operating correctly, but also for the pipe work leading to the water making plant equipment. The IP65 Control boxes were mounted above the floor plates, allowing the crew to observe the indicator LEDs. The supply came directly from the 220VAC Distribution board at the aft of the engine room and all cabling was suitably dressed and secured on existing cable trays beneath the floor plates.

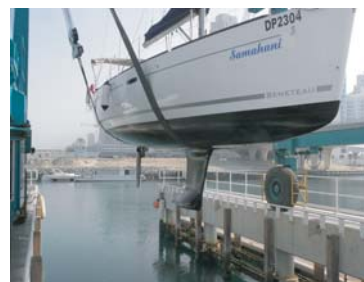
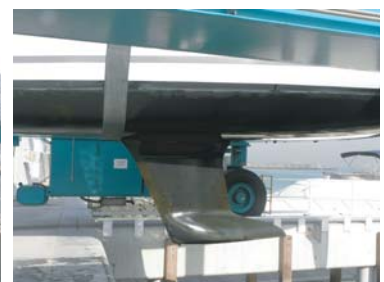
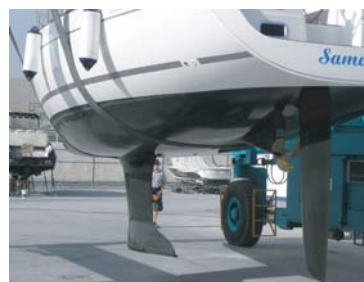
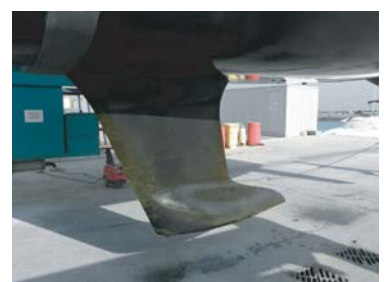
Pictures of boat being removed from Dubai's fertile waters after 1 year with Sonihull

The owner stated that within the first two weeks he knew it was working as previously every two weeks he would have to degunge the speed log paddle wheel. In the last year he has not had to do it once!

The system has been installed for well over 2 years now with excellent results. So much so that the speed log paddle wheel has not needed cleaning since the Sonihull system was installed!

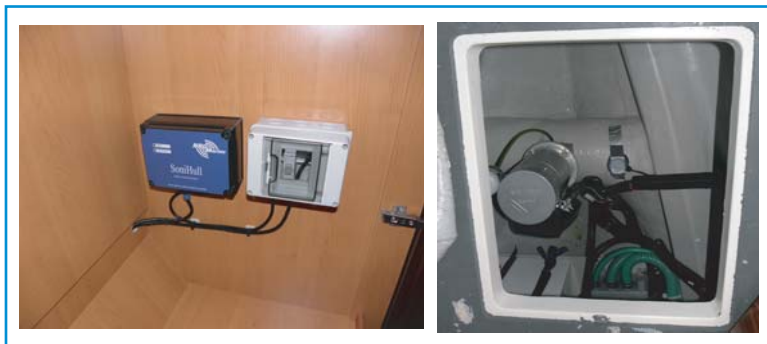
Transducer location:

Sonihull Mono mounted adjacent to the propellers shaft's.

*Transducer location: Duo, both mounted adjacent to the propellers shaft's .*

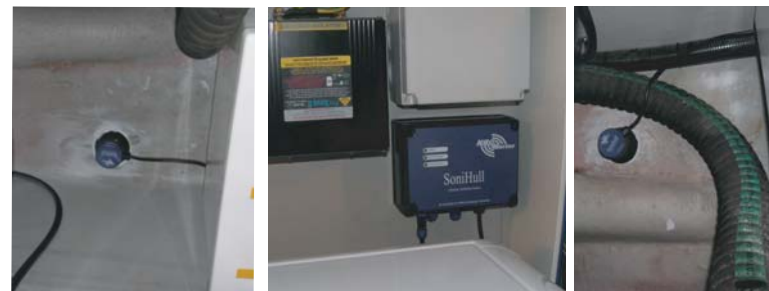
Transducer location:

Sonihull Duo mounted directly to the bow thruster tunnel.

*Mono, mounted directly to the bow thruster tunnel.*

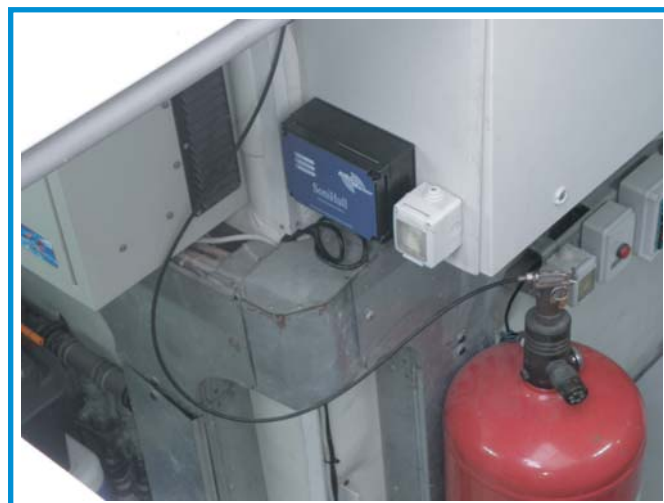
The results have been fantastic and now plans to add an additional mono to protect the bow thruster and bow area of the boat that are not covered too well by the transducers mounted at the rear of the 62 footer.

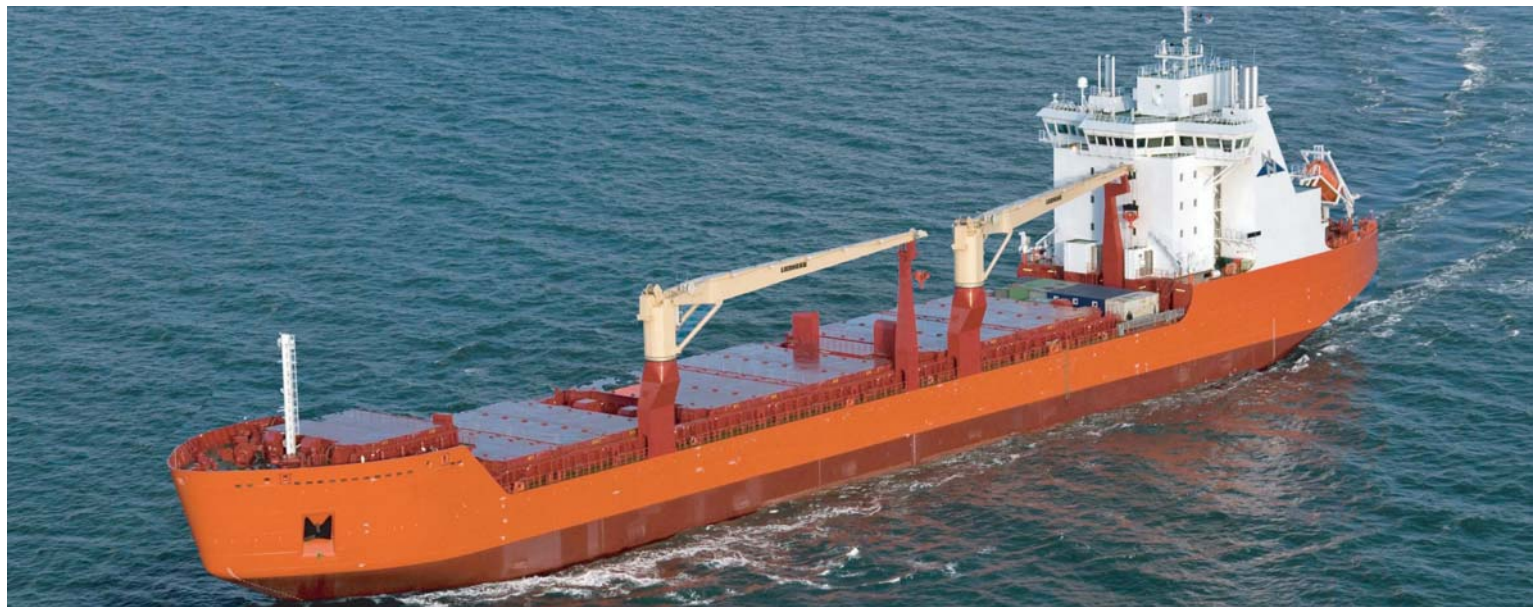
Multiple transducers installed in the hull. The transfer rate of the ultrasonic signal is much higher on steel than fiberglass and therefore most effective. On commercial ships each transducer should be calculated to a 3-5 metre radius on steel hulls to obtain ultimate results.

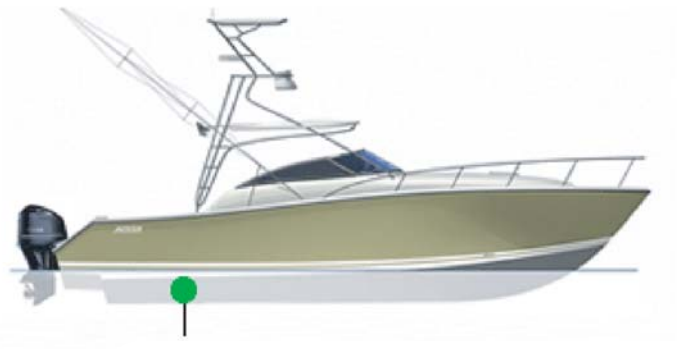
Sonihull Mono Positioning

Positions shown for illustration and guidance only,  
Note: Actual mouting is on inside of Boat Hull
